A STUDY OF THE HISTORICAL CONSTRUCTION TECHNOLOGY OF BELL TOWERS IN CYPRUS

MARGARITA L. PETROU^{1*} AND DIMOS C. CHAMPIS¹

Abstract. *This paper aims to present the historical construction technology of churches' bell towers in Cyprus, starting with the initiation of their use and addressing the development of their distinctive morphology adapting and mixing various architectural styles. Traditional bell towers are tall and slender unreinforced masonry structures that are known to be particularly vulnerable to earthquake actions encountered in seismogenic regions, such as Cyprus. Therefore, iron and wood elements with high tensile capacities were commonly utilized in Cypriot bell towers in the form of ties. In particular, the bell tower of Saint John's church in Psevdas village was constructed using such technology and is an example case studied in more detail in the present work. This tower suffered a partial collapse during an earthquake on May 12th, 2016 and underwent restoration within the next year. Based on the knowledge gathered from the case of the damaged tower and the visual inspection of other bell towers in Cyprus, the use of timber and iron ties in these masonry struc

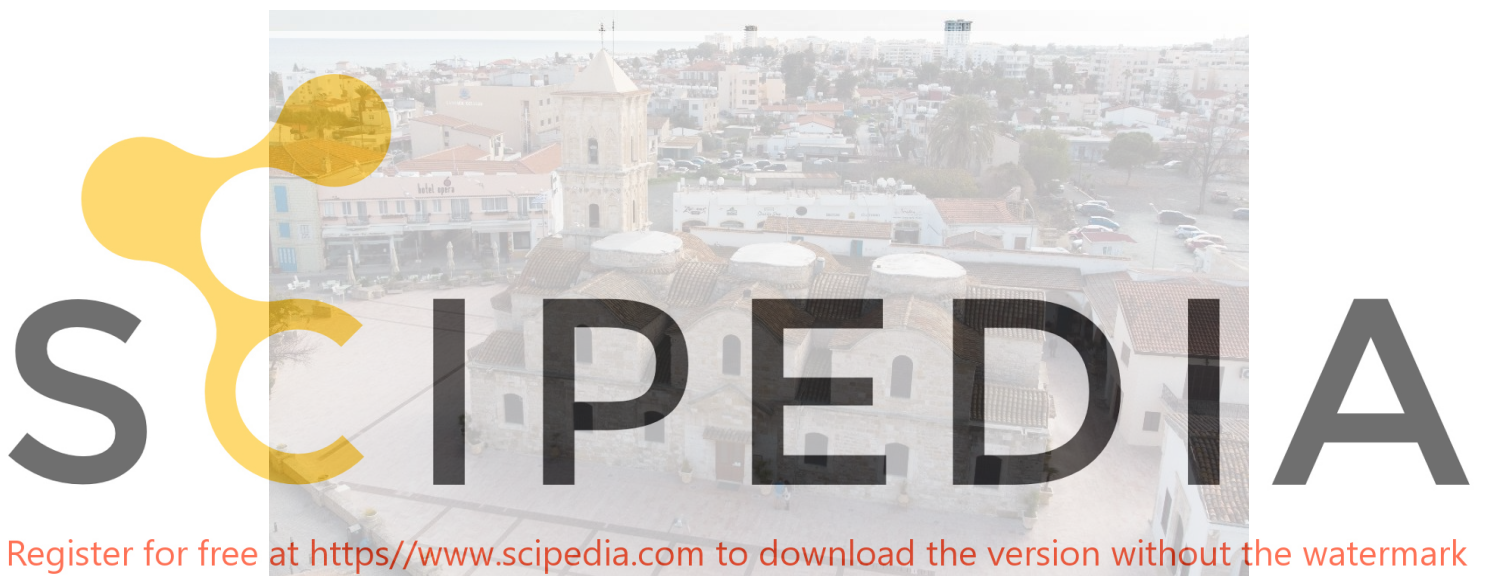
Figure 2: Church of Saint Lazarus, Larnaca

The liberation of the religious affairs and practices resulted in the development of a new architectural style, the Cypriot Neo-Gothic style, which appeared first on the newly constructed bell towers and later transferred to new churches. The combination of Neo-Gothic towers with churches of Byzantine or Franko-Byzantine style is a frequent phenomenon in Cyprus. A notable example of this is the church of Saint Lazarus in Larnaca. The massive multi-dome Byzantine basilica was built with the funding of the byzantine emperor Leo VI (866-912) in the 890s. In 1857, a bell tower following the Italian standards was added on the southside of the chancel [10]. The bell tower is 23 m tall and bears detailed carved ornamentation and two belfry storeys (Fig. 2).

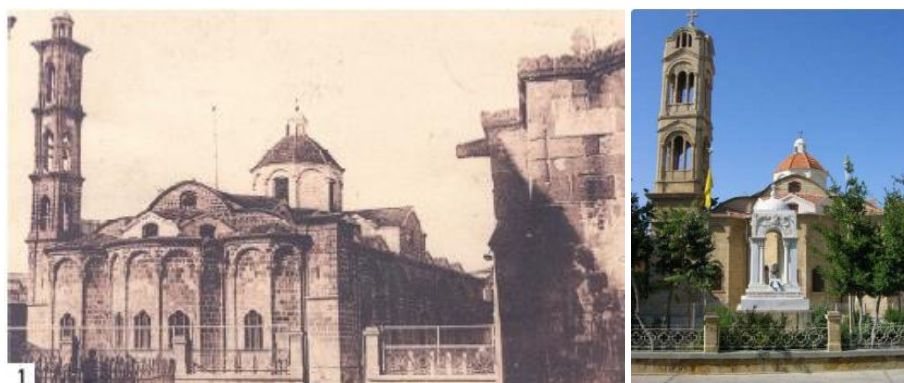
Figure 3: The old masonry (left) [6] and current concrete (right) [15] bell tower of the church of 'Panagia Faneromeni', Nicosia

Between 1856 and the 1930s, the primary material used for the construction of the towers was limestone masonry. In the 1940s, the use of reinforced concrete gradually spread, replacing stone masonry. The form and structure of the bell towers follows the typical typology described firstly. The example of the bell tower of the church of 'Panagia Faneromeni' located in the historical centre of Nicosia indicates the transitional stage reflecting the change of the construction material. The current 26 m tall tower was erected in 1938 and is made of concrete and regular masonry blocks, while metal brackets are installed at the perimeter [14]. The current tower designed by the architect Theodoros Photiades, the first Cypriot architect, was built as a replacement of the original masonry tower which was destroyed during the 19th century [15] (Fig. 3).

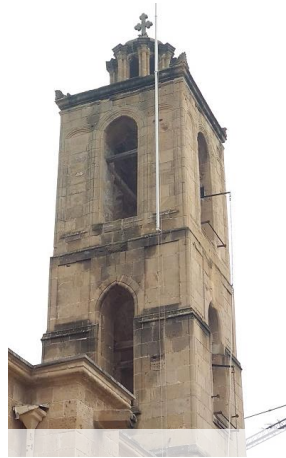
Figure 5: Bell tower of Saint John's Cathedral with timber ties, Nicosia

of various relevant construction and intervention technologies. Among such technologies, the installation of iron and timber ties has been often used as an effective way to better cope with the earthquake hazard in Cyprus [19]. Hence, tie-rods were installed during the initial construction phase on the arches of bell towers, as well as on opposite walls of the churches’ main body. The use of timber tie-rods in Cyprus is minimal. An outstanding example application of this technique employing timber ties is on the bell tower (built in the 1890s) of archbishopric cathedral of Saint John (built in 1662) in Nicosia [20] (Fig. 5). On the other hand, the use of iron tie-rods was more popular and many example applications can be found in various regions of the island. Moreover, iron ties (cramps) were occasionally installed between the storeys of the bell tower, in order to better fasten the entablatures.

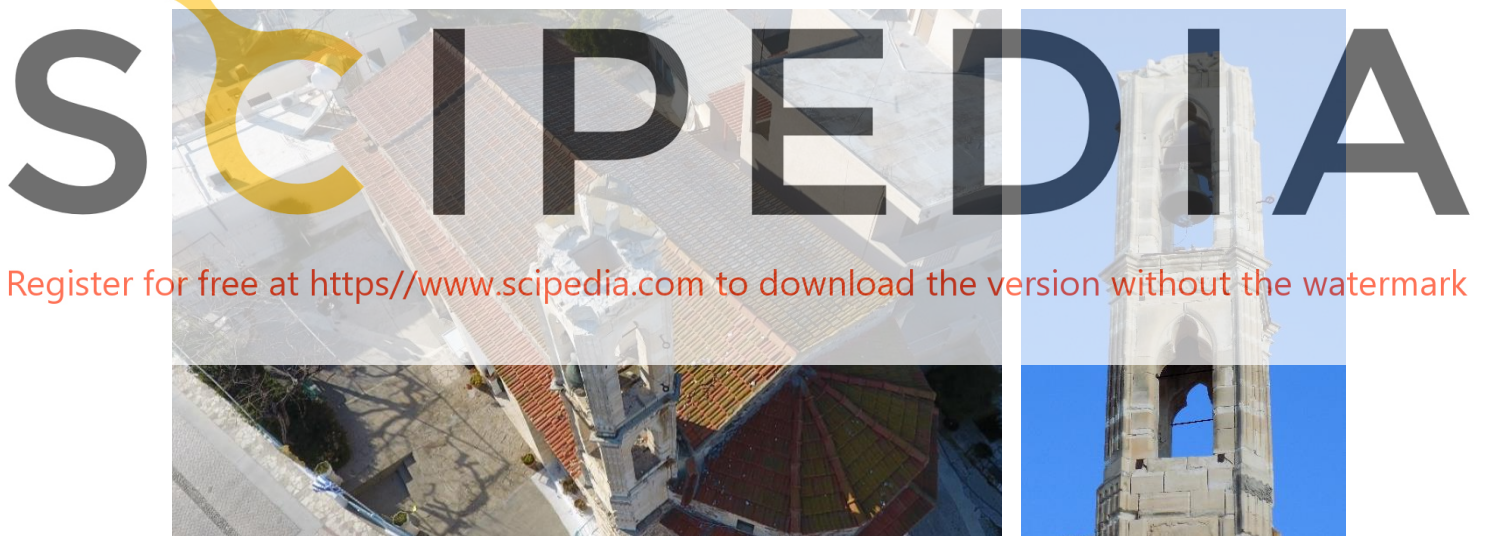
Figure 6: Bell tower of Saint John's church in Psevdas village after the earthquake (photos taken in February 2017)

The earthquake caused the collapse of the canopy, the three out of four acroteria and a large part of the upper entablature. Only two out of eight pillars of the canopy's arches were standing after the earthquake (Fig. 6). Most of the fallen parts turned into rubble.

During the visual *in situ* inspection of the damaged bell tower of Saint John's church, it was found that iron tie-rods connect the intrados of the arches of the two storeys, while a grid of four iron cramps fasten each storey at the height of each entablature (Fig. 6). The bell hangs from an iron bar anchored into the masonry pillars. There is another iron cramp just beneath the bell, which protects the masonry from the mechanical action (erosion) caused by the friction between the bell's rope and the stone. All metal elements were installed during the initial construction phase using gypsum mortar.

The exposure of the iron elements of the bell tower to atmospheric oxygen and humidity led to corrosion. This resulted in cracked stone units and exposed anchorages of the cramps, which became visible at the exterior face of the bell tower (Fig. 6). This phenomenon was observed also in other cases, such as at the bell tower of Saint John's church in Larnaca (Fig. 7). However, cramps may not always become visible at an exterior wall face, as metal elements may have been placed in protected interior parts of the structure, which hinders the oxidation process from taking place.

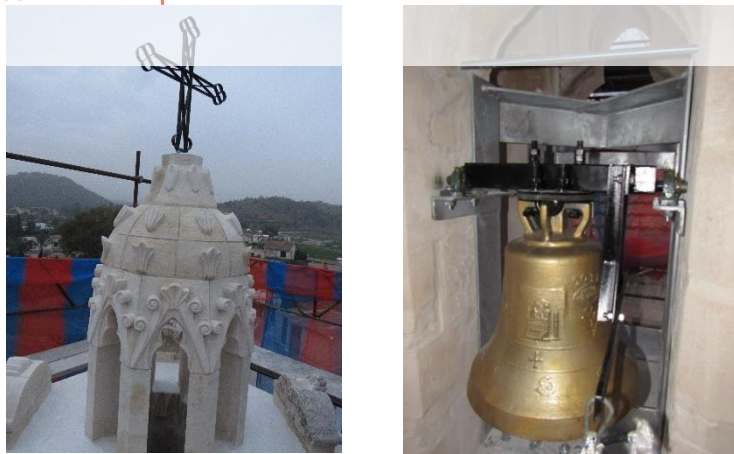
Figure 8: Restoration (left) and strengthening (right) of Saint John's bell tower in Psevdas (photos taken in December 2017)

During the restoration works, the canopy and the whole upper part of the bell tower were reconstructed to their original form. The corroded craps and tie-rods of the upper storey were replaced by similar stainless-steel elements. The weathered stone units were replaced with similar ones and the cracks were sealed with lime grouting. Finally, a special dedicated base for the bell was installed, in order to prevent damage to the masonry due to dynamic excitation from the bell's swing and the corrosion of its iron base (Fig. 8).
